WORKSITE SETUP DURING ASBESTOS REMOVAL WORK ON THE MONTPARNASSE TOWER

CASE STUDIES

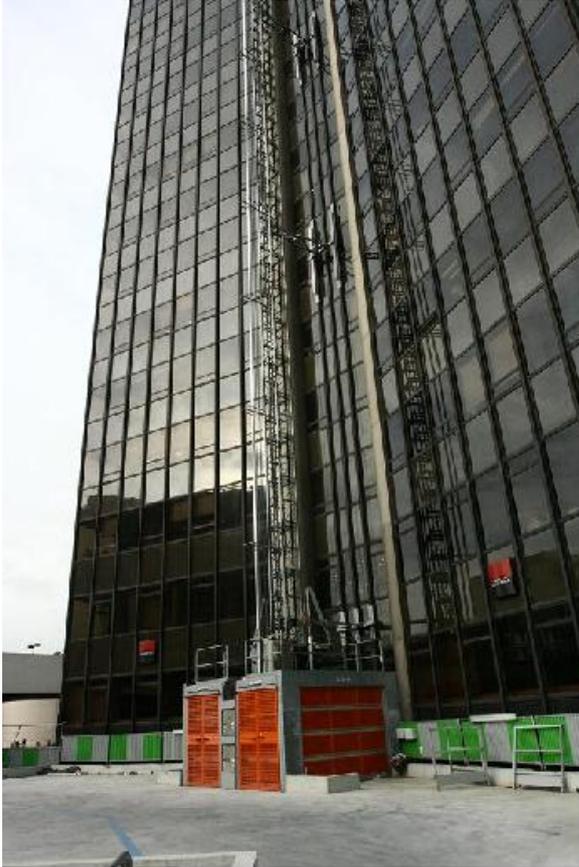
Two outdoor freight elevators dedicated to the site . capable of carrying a load of 3.2 metric tonnes in a volume of 10m³ . were installed on the southern façade of the tower. Regular users could, therefore, continue to use the 25 elevators within the tower.

Picture 2: View on the elevator cabins of the Maine-Montparnasse Tower (copyright: ICADE)

Each elevator cabin carried equipment and material necessary for the renovation of the various levels. The elevator would climb the length of a central mast of 200 metres fixed to the façade. Weighing 43 tonnes, this structure sat atop a metal-framed base, itself on blocks fixed into the ground. This setup also allows the companies responsible for disposing of the asbestos to remove it externally.

In order to link each level to the elevator cage, a gangway equipped with a landing door was installed. On the forecourt, a technical base housed changing rooms and lavatories for the workers, as well as a transfer and delivery area of around 700m² was installed at the foot of the elevators to allow for the loading and unloading of equipment and waste.

Initially set to be operational in 2007, the putting into service of the elevators had to be delayed by several months in order to reinforce the anchorage guaranteeing the stability of the central shaft, allowing the machine to withstand winds of up to 200 km/h.

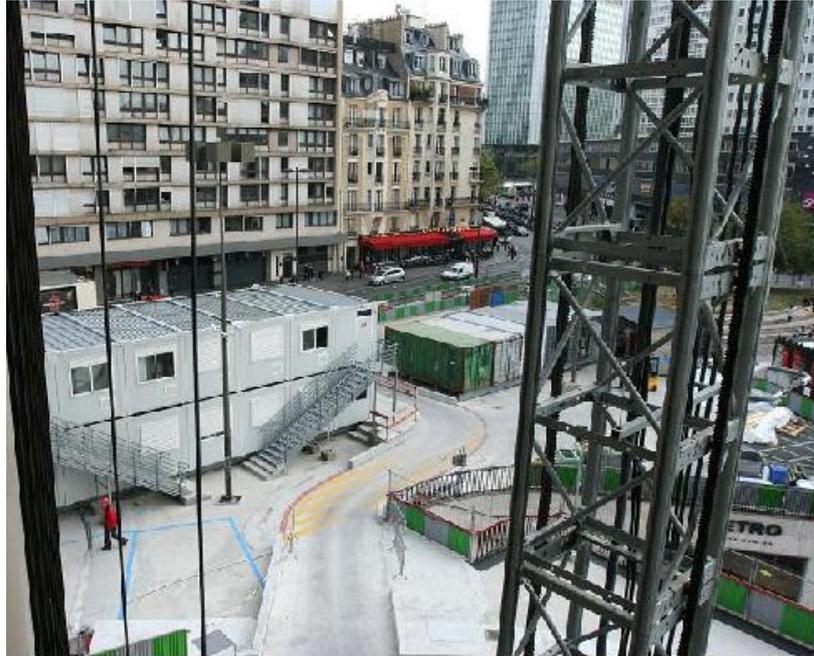
Picture 3: View of the technical base (copyright ICADE)

The technical base at the foot of the Tower proved to be very useful and permitted monitoring and limiting of access to and from the worksite.
