## **MODERNISATION OF A CERAMICS FACTORY TO PREVENT MANUAL LIFTING**

AB Dvarcioniu, keramika, Keramiku g. 2, LT-10233 Vilnius

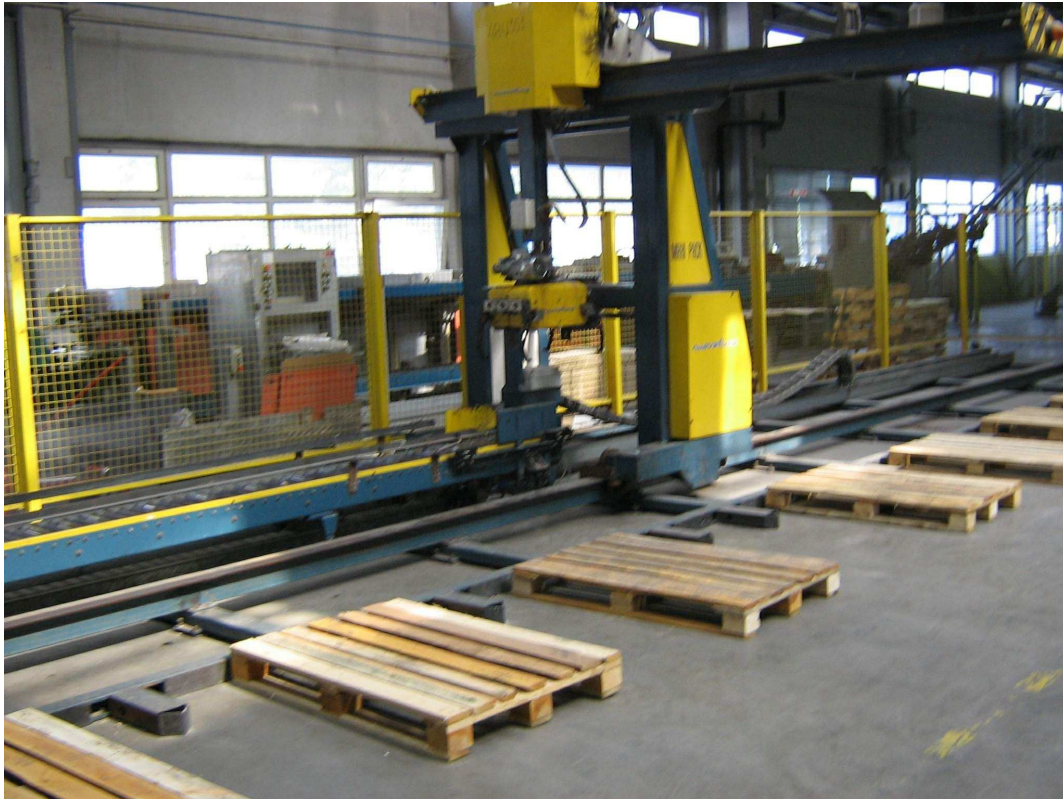
Figure 1 Automation of the tile-sorting line

The mechanism takes and puts the empty pallets into the relevant place automatically. It includes an automatic assembly line, control box and automatic intake mechanism, allowing the maintenance of eight pallets simultaneously. The operator of the mechanism monitors its control and, in the event of any process failure, resets the operation in automatic mode. The worker uses a fork-lift truck to take away full pallets. Photo sensors protect the area maintained by the mechanism. If anyone steps into the yellow safety zone, the mechanism is stopped automatically. Electricians or metalworkers are called to deal with more complicated breakdowns

As a result of the risk assessment, it was decided to modernise the unit that put tiles on pallets. Two robot manipulators were installed to replace eight of the 16 workers. Following automation, the workers were trained to manage the computer-controlled mechanism.
