## AUTOMATION OF VISUAL INSPECTION

Slovalco, a.s.

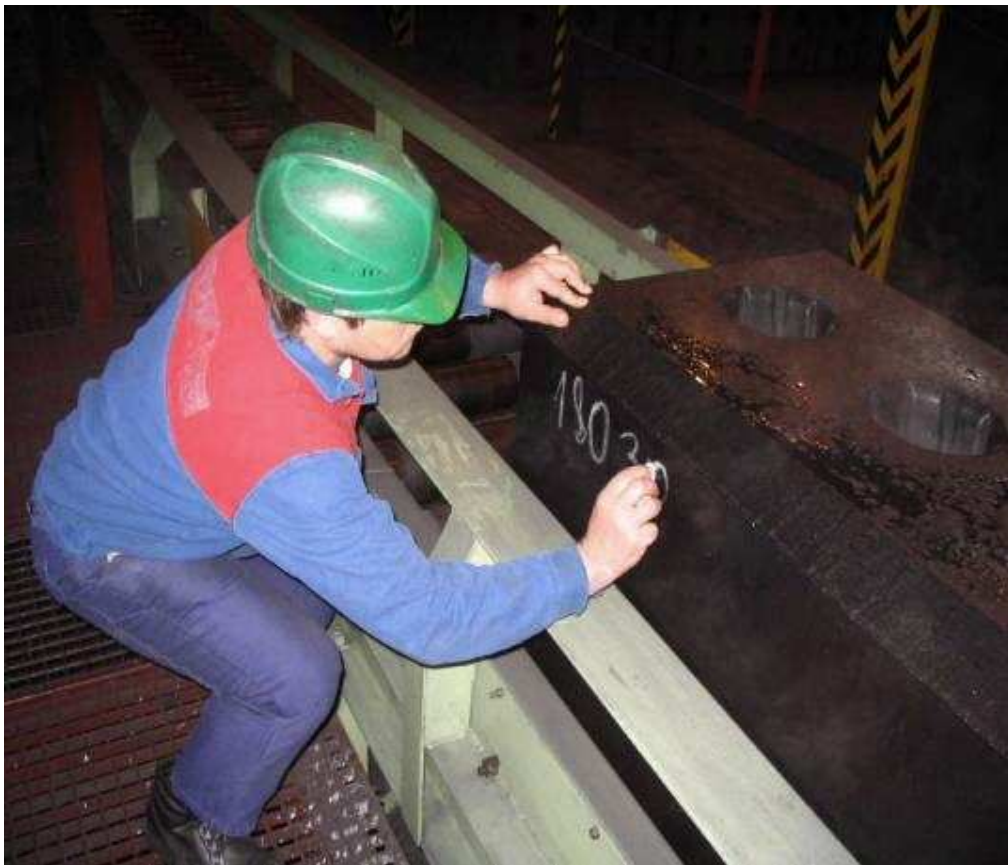
Figure 1 Marking the block with chalk in squatting position

Aluminium manufacturing needs anodes made of carbon. The plant produces anode blocks composed of calcinated petrol-coke, liquid coal tar pitch and mix of scrap material. Mixed material is formed to block-shaped anodes by a vibrating compactor. Blocks are around 0.5 m high, over 1.5 m long and weigh one tonne. A worker used to stand at the end of the production line for the whole shift visually inspecting the blocks to detect manufacturing defects such as cracks or holes. Output is around 20 blocks per hour so every three minutes the worker inspected a block and had to squat down to the level of the block to mark the block with the identification number. There is a draught at the workplace and it is cold in the winter. There were 12 persons rotating in this position from the 80 workers of the production unit.

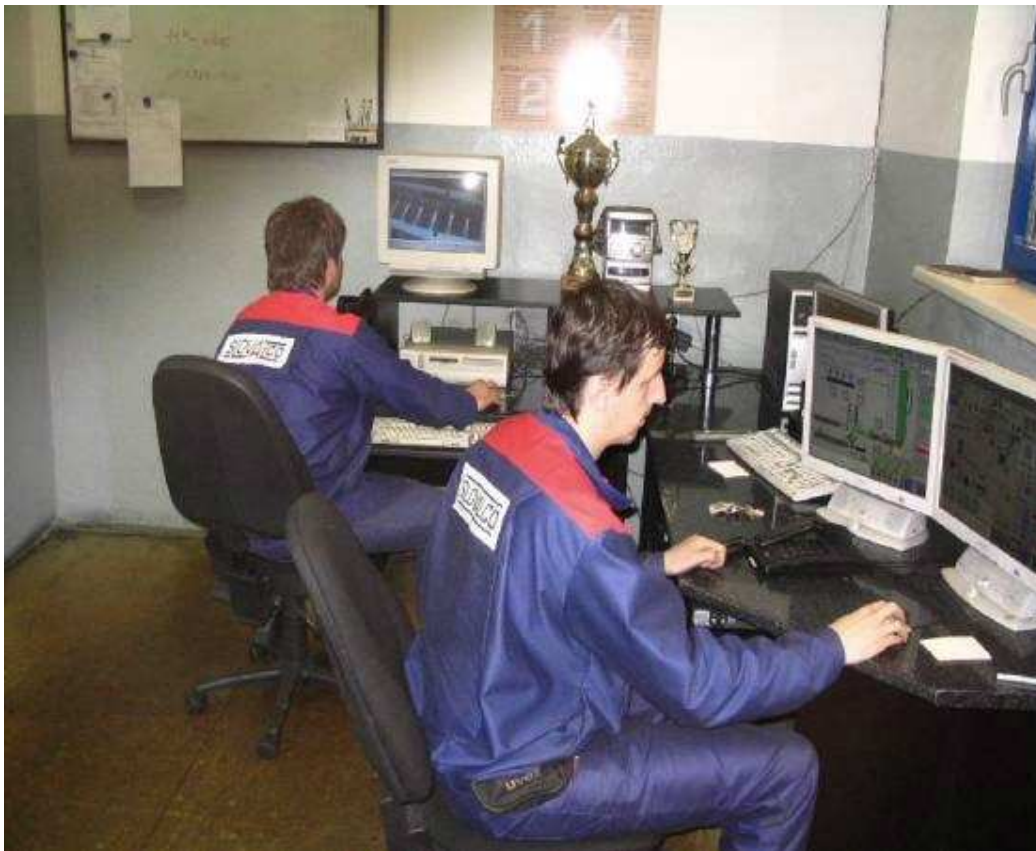
Figure 2 Workers inspect a block from the control room

The company has installed video cameras besides the conveyor. The video signals are sent to a separate control room. A high-pressure painting device with a printer replaced the marking of blocks with chalk. There was no problem encountered.

Risks from unfavourable ergonomic conditions were eliminated. Workers can inspect blocks from the comfort of the control room. Industrial cameras have eliminated the need to stand for 8 hours beside the conveyor. The painting-printing machine has replaced squatting down for marking. Workers have to go out to the conveyor area only once an hour. They reject faulty blocks at the end of the shift by pressing a button. The one-off investment costs of the high-pressure painting device, the printer and the camera system were SKK 1,485,721 (c €44,200).

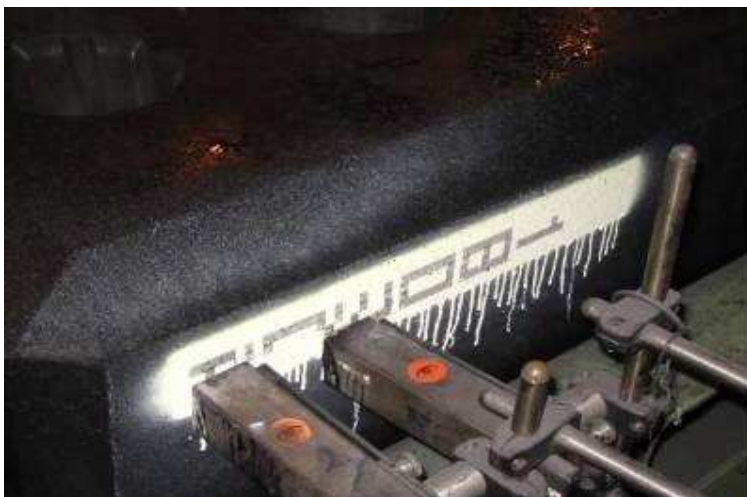
Figure 3 Automated printing device marking the blocks. Photo by Slovalco a.s.
