## PROACTIVE AND REACTIVE INTERVENTIONS TO IMPROVE SAFE MAINTENANCE (AWARDED CASE IN THE EUROPEAN CAMPAIGN ON SAFE MAINTENANCE 2010/2011)

- Interventions on a Capsule Filling Machine to improve safe operation - corrective maintenance
- Improvements arising from the risk assessment of the preventive maintenance of a coating machine
- Improvements arising from the risk assessment of the preventive maintenance of a house vacuum machine

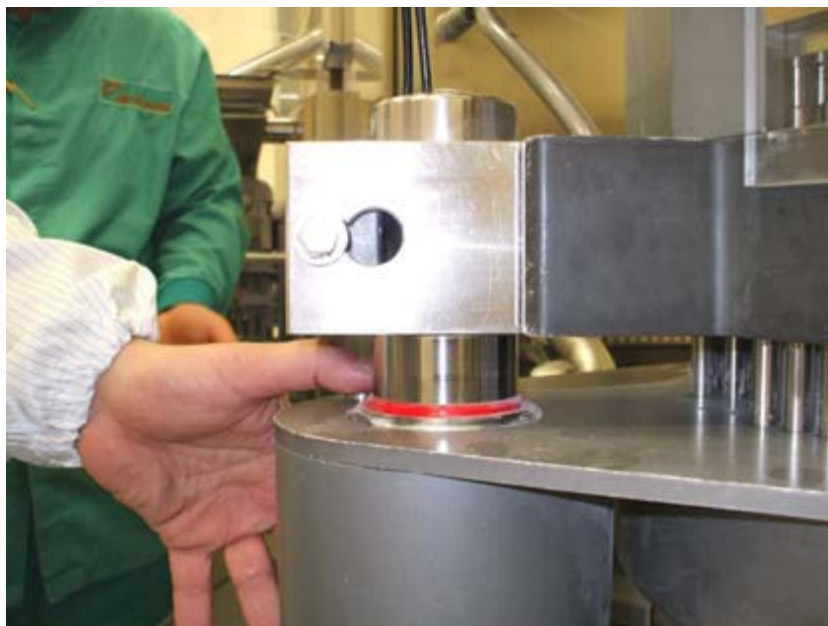
Fig.1

During the assembly process, an accident occurred whereby the operator's left hand thumb was squeezed between the tamping pin guide and the cover plate.

Thumb was trapped between the cover plate and the tamping pin guide

Investigation into this accident highlighted the following problems in the machine features:

- Accessibility of the operator to moving parts when the machine is in inching mode (i.e. moving stepwise at a slow pace). The inching mode could be operated with only one hand allowing the person to use the other hand to intervene on the machine.
- The area where the person had his thumb trapped was not properly guarded.

Following a thorough investigation into the root cause of this accident, the following solutions were implemented. These were direct interventions performed by our maintenance personnel in order to render the operation of the capsule filling machine in inching mode safer for both production and maintenance personnel.

- Installation of a guard to cover the areas where there are moving parts such as the tamping pin guide and cover plate.

Installation of a second inching button such that operation of the machine in inching mode can only be done using both hands at the panel. This effectively removed the risk that an operator uses one hand to inch the machine while checking the machine with the other.

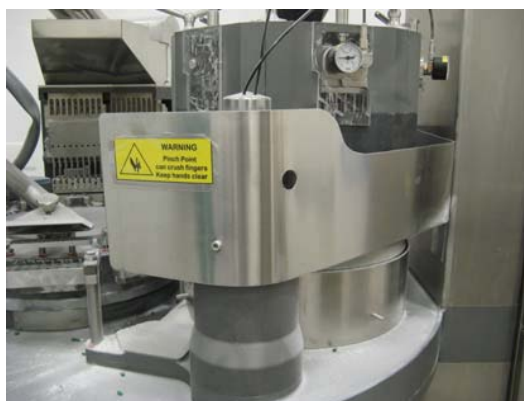
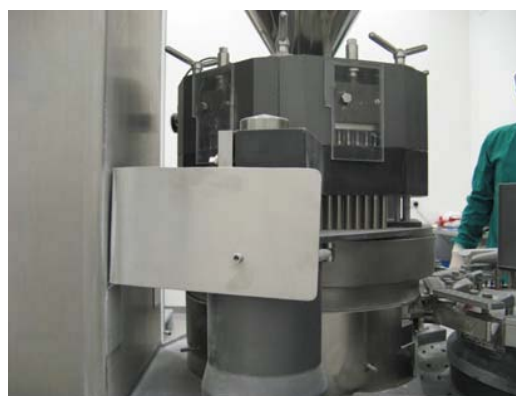
Fig. 2 New guards were installed to cover the area where moving parts were accessible

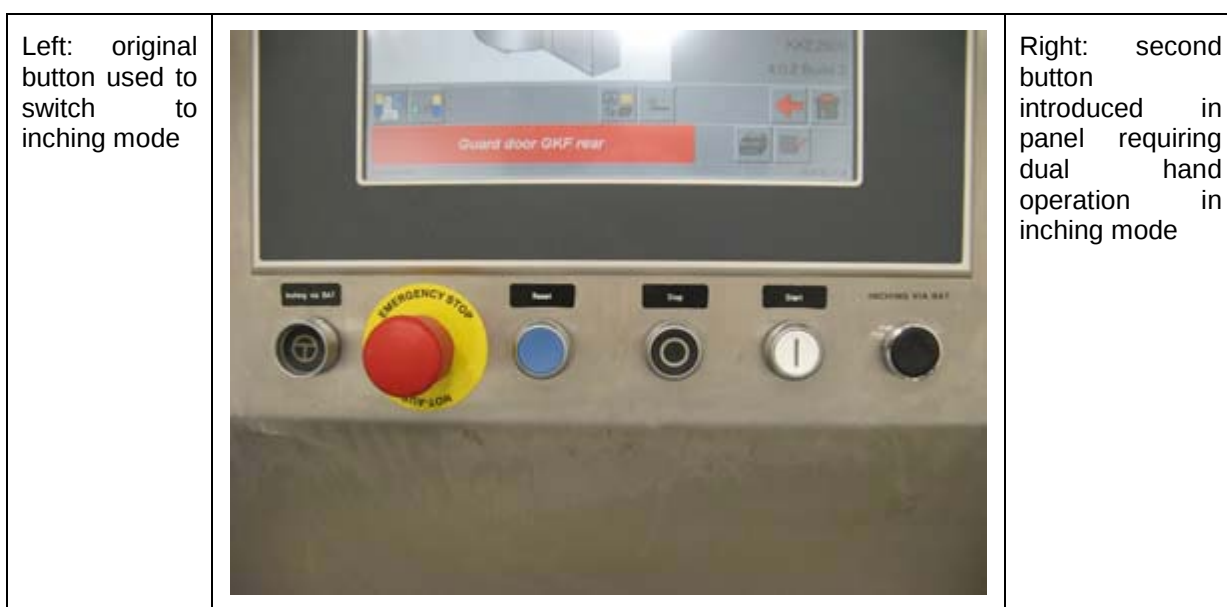
Fig.3 – Detail of improvements made

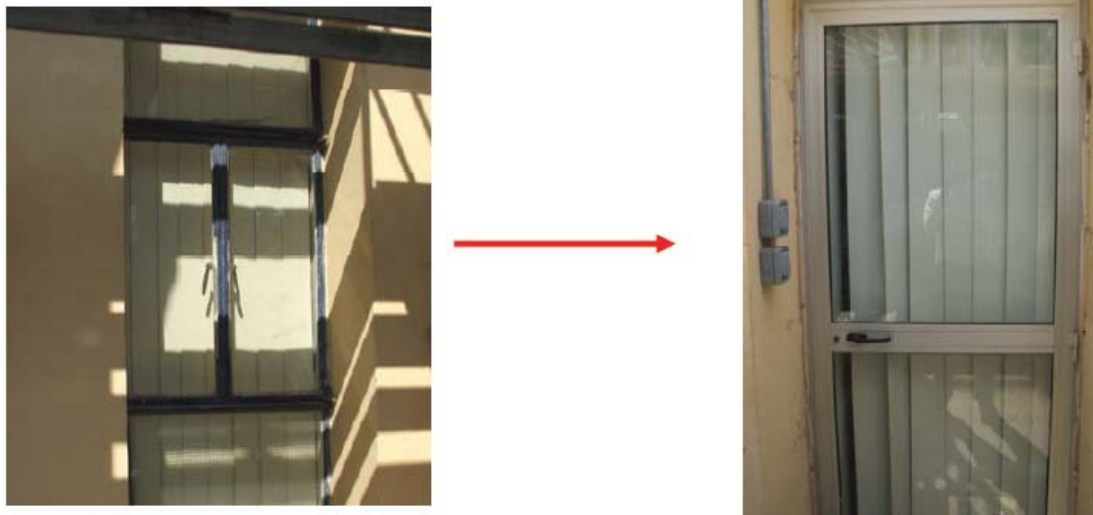
Fig.4 Access to external technical area was originally through a window which was converted to a door for easier and safer access

- Improved accessibility to the external technical areas: Access to the external technical area was originally through a window, which, following the Risk Assessment, was converted into a door. Moreover, accessibility to perform the jobs required on the dust collector was improved through the provision of a working platform.

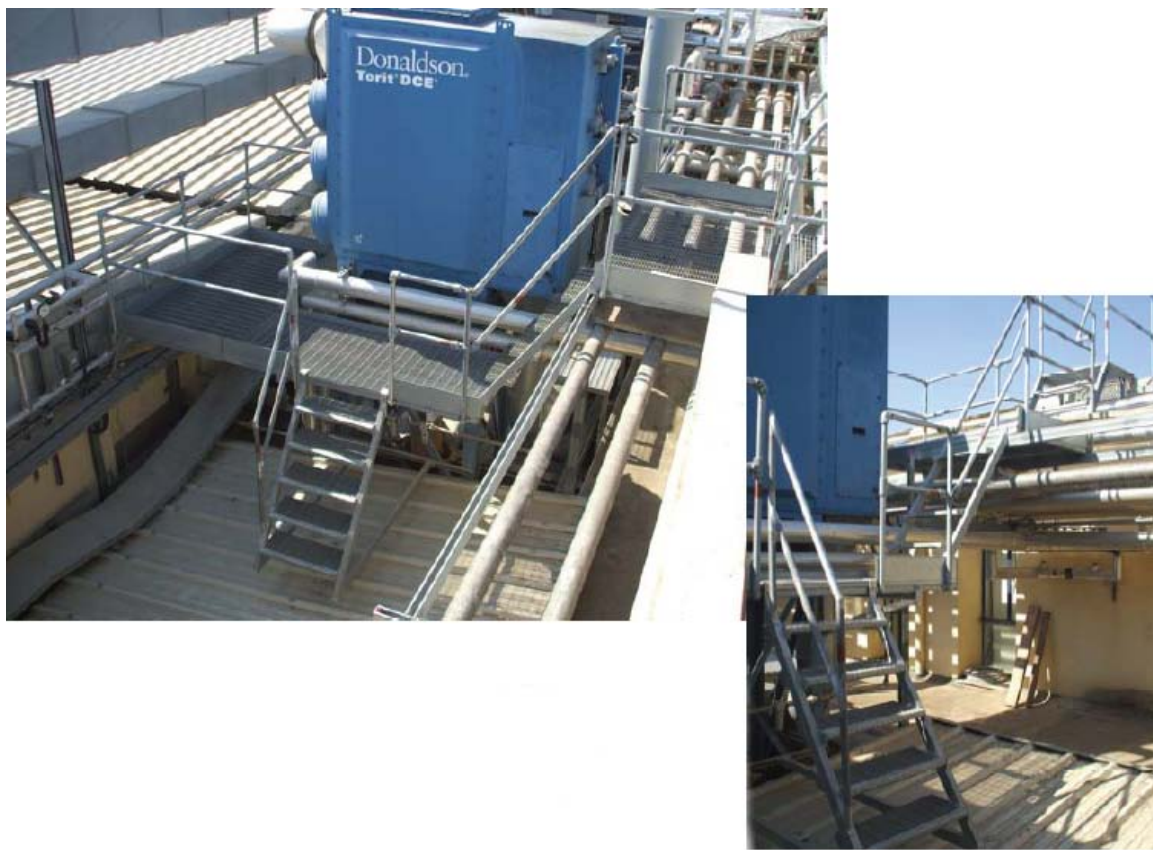
Fig.5 Installation of a working platform around the Dust Collector improved accessibility and rendered the preventive maintenance job safer

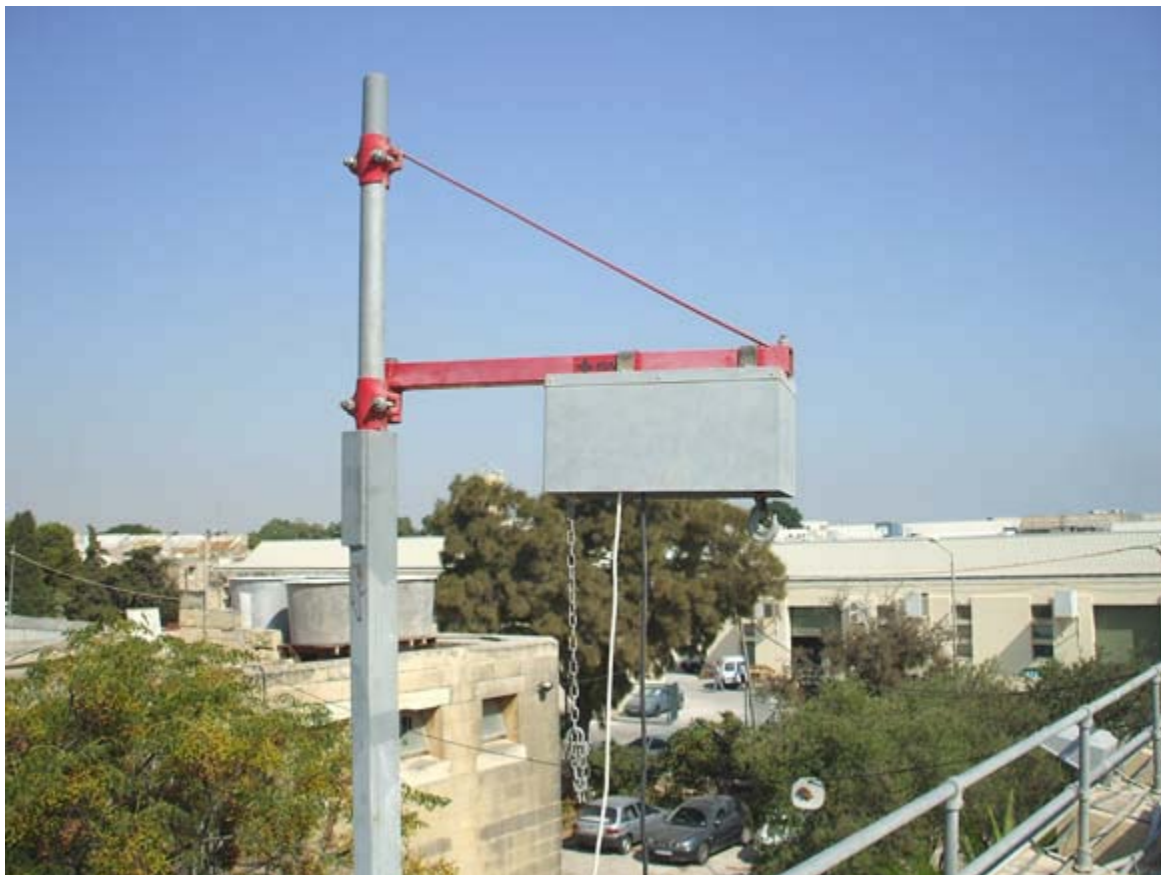
Fig.6 Hoist device located on roof area to assist technicians in transporting the pharmaceutical process waste bags

**Manual Handling concern:** As part of the monthly preventive maintenance activity, pharmaceutical process waste is removed from the dust collector to be prepared for proper disposal. This involves the collection of pharmaceutical dust in disposal bags and their transportation to a waste storage area. Considering the relative difficulty to access the area and the need to transport this waste over a relatively long distance to the storage area, manual handling concerns were raised in the risk assessment. The main difficulty was in the carrying of these process waste bags from near the dust collector up across the roof and then down to the waste storage area. In order to address this concern, a lifting device has been installed in the proximity of the dust collector such that the bags could be hoisted using this winch device. Moreover, Actavis Ltd. has rolled out a Manual handling training program for all employees, including maintenance technicians. This training program covers the correct techniques for the handling of loads and also includes exercises to help protect the back and minimize injury.

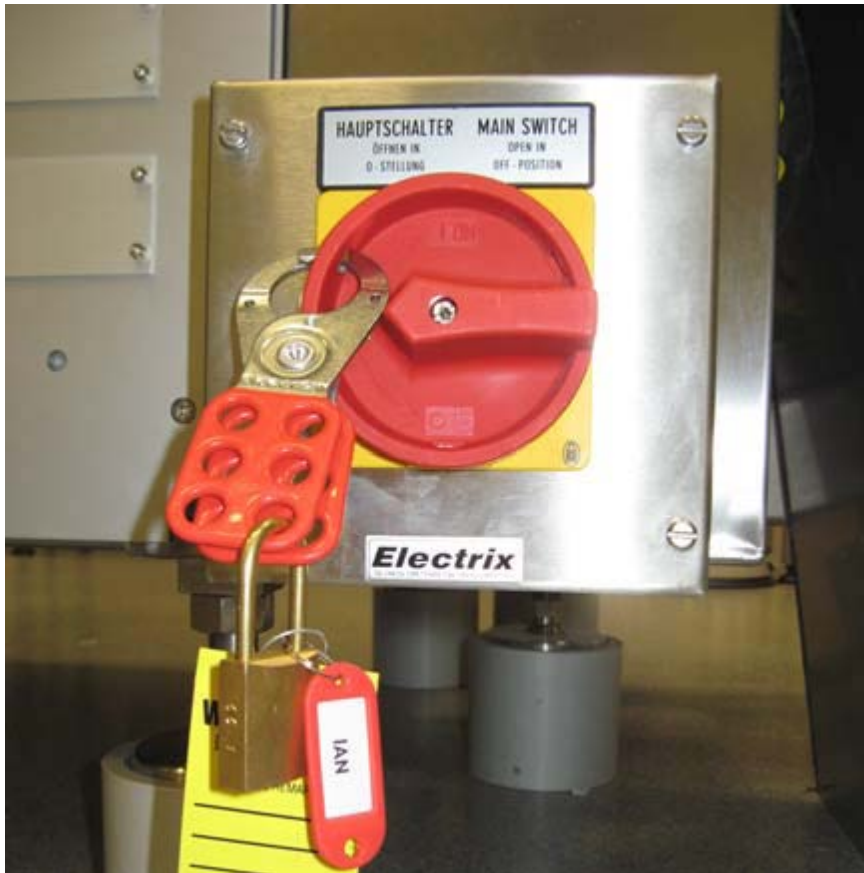
Fig.7 Lock off device used to isolate equipment prior to a maintenance activity

Electrical hazards: Any preventive maintenance activity commonly involves the intervention by a technician on equipment operated with electricity. This has its inherent hazards. One of the most critical risks identified during the risk assessment of most preventive maintenance jobs was the risk of an operator or another employee operating a machine while a preventive maintenance job was being done on the same equipment. In view of this, Actavis has placed a lot of effort into the introduction of safe systems of work for such situations. One key improvement in this respect is the implementation of an Engineering Lock off procedure. This lock off procedure (ES – 43) describes the system being used to safely isolate all sources of energy/ power to equipment to safeguard one's own health and safety and that of other persons. As a result of this procedure, Safe Isolation Instructions (SIIs) are being issued for all equipment, describing the locks and procedures to be used prior to starting any preventive/corrective maintenance work on a piece of equipment. This was also implemented for the maintenance of the coater machine where the isolator of the machine is locked off by the maintenance technician before preventive maintenance work is commenced.

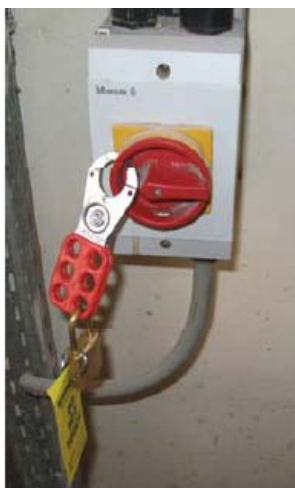
Fig. 9 Electrical Isolator  
Locked off and tagged

- Safe isolation instructions to lock electrical and compressed air supplies. This is complemented with the TOLOT (ES-43) procedure system.
- Instructions were issued such that when replacing heavy sacks, the activity is always a two men job.

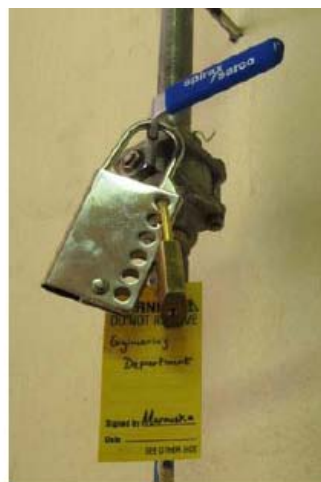
Fig.10 Manual Compressed Air Valve  
Locked off and tagged
