## **REDUCING MUSCULOSKELETAL LOAD IN A FISHING ENTERPRISE**

### **2. Description of the case**

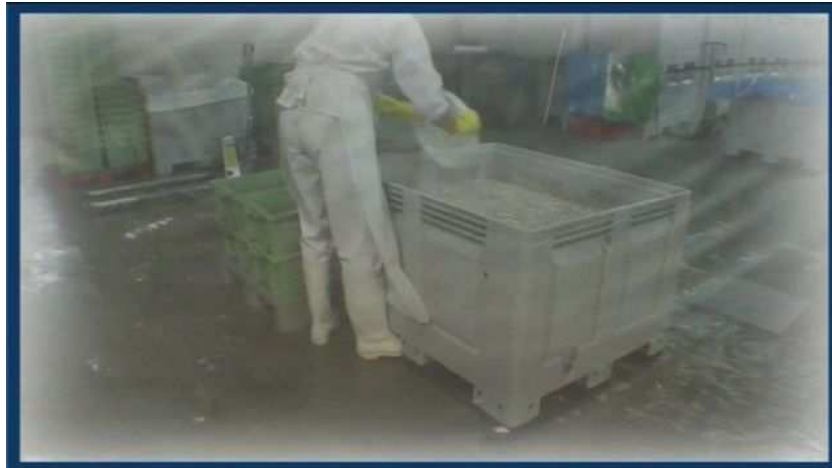
**Figure 1: Before improvement - a large container filled with brine**

There was a problem with removing fish from a large container filled with brine (Figures 1, 2, 3 & 4). This task was done manually, using sieves, and resulted in workers developing musculoskeletal problems. The fish were then moved to an open crate where the brine drained away. To eliminate musculoskeletal load, automation was implemented in this part of the production line. Next, workers used a manual trolley to transport pallets, filled with boxes, to a weighing and packing station.

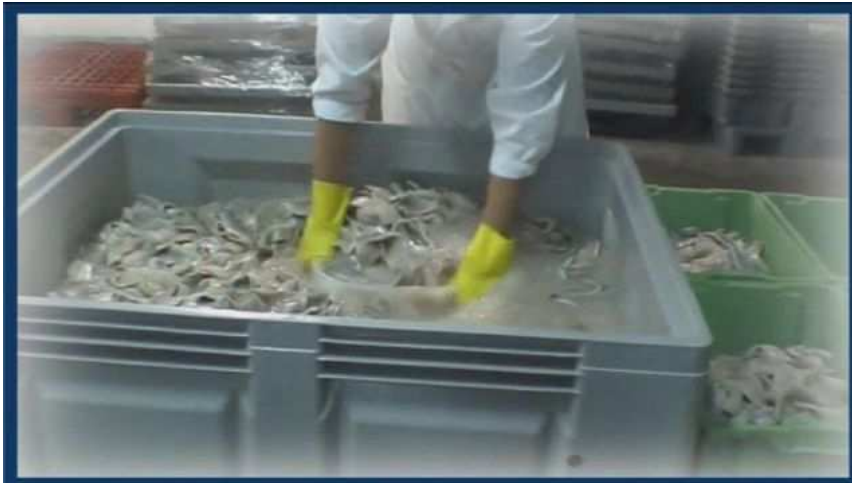
**Figure 2: Before improvement – collecting fish in a sieve**

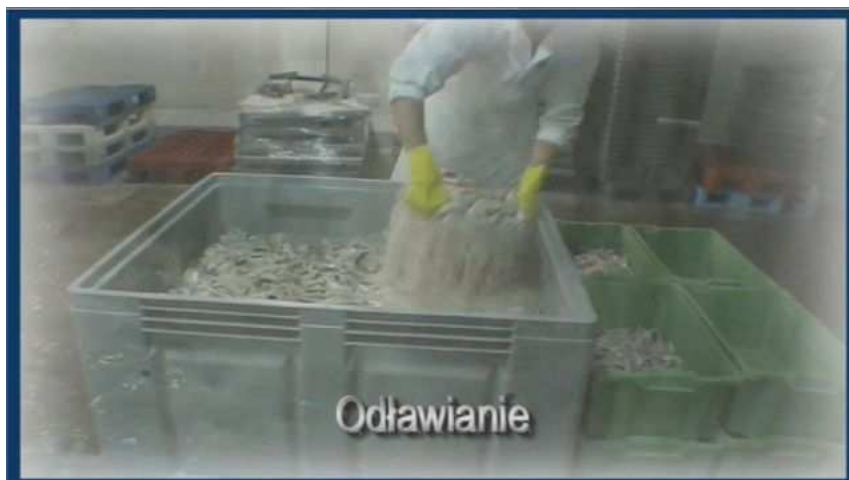
**Figure 3: Before improvement – transferring fish via a sieve from the brine container into smaller boxes**

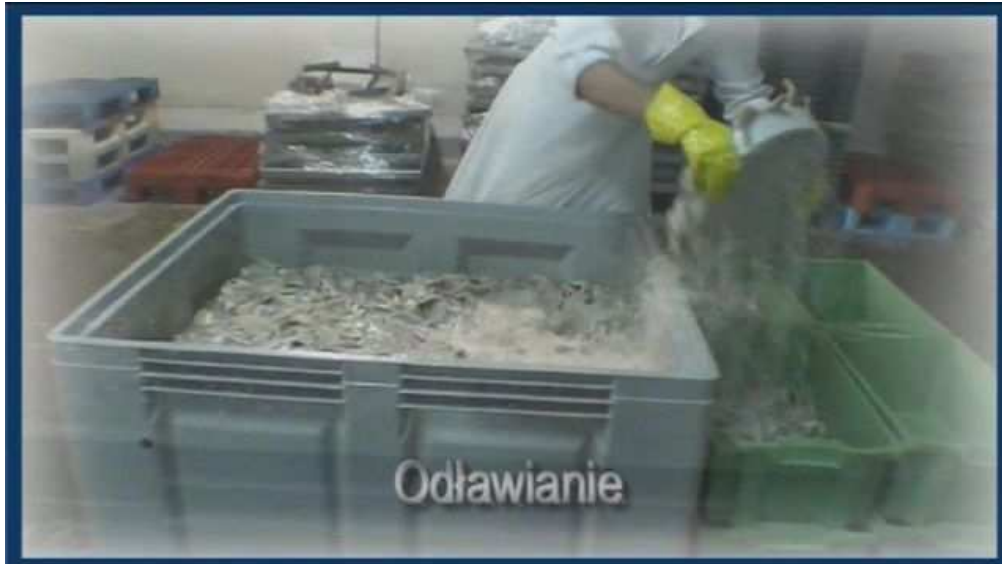
**Figure 4. Before implementation of the new solutions, employees were exposed to high musculoskeletal loads, awkward postures and repetitive manual handling**

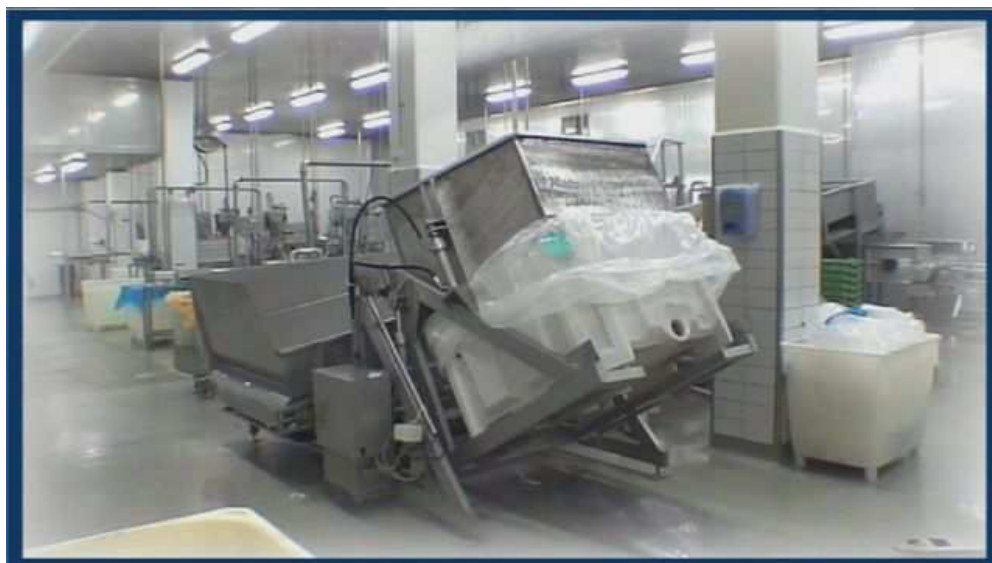
**Figure 5. After implementation - the brine container on the mechanical tipper**

A mechanical tipper (Figures 5, 6 & 7) was installed to eliminate the need to manually pick up fish and so avoids the continuous bending over, which was causing the manual-handling problem. The large plastic container of fish in brine is situated on the tipper, which by means of a control panel, workers can use to tip fish onto an automatic draining line. The draining line (Figures 6 & 7) is connected to a conveyor belt. Fish are automatically transported from the draining line through the conveyor belt onto parallel production lines, where employees weigh the fish and insert them into individual packs. Workers take the fish directly from the conveyor belt to a weighing station. The company management had considered introducing automatic scales, which were tested in the plant. However, since fish material is not sufficiently homogenous, these automatic scales could not be used. Currently, the manual pallet trucks are being replaced with electric trolleys to reduce the need for manual handling yet further.

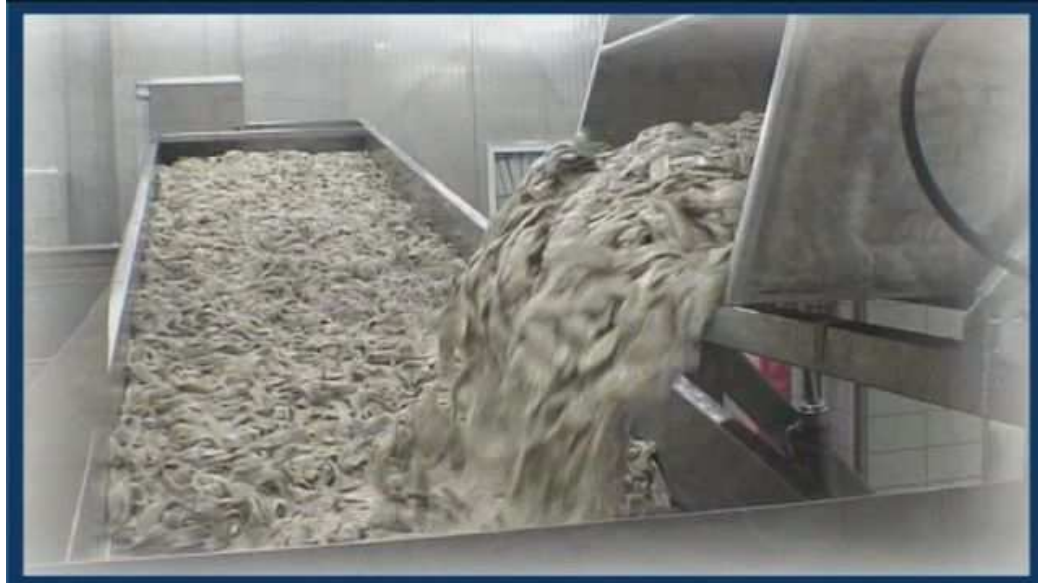
**Figure 6. After implementation - the mechanical tipper transfers the contents of the brine container to the automated draining line and eliminates the need to manually pick up fish**

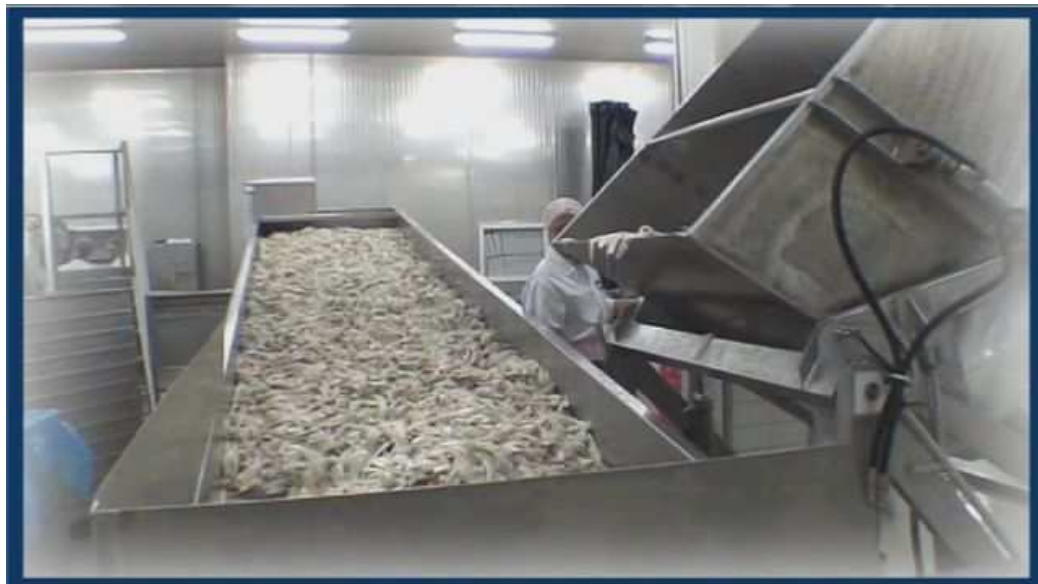
**Figure 7. After implementation - the automated draining line transfers the fish to the weighing and packing area and eliminates the need for workers to transport fish using trolleys.**
