## REDUCING ACCIDENT RATE DUE TO ERGONOMIC HAZARDS IN THE CHEMICAL INDUSTRY

Clariant Ibérica Producción S. A.

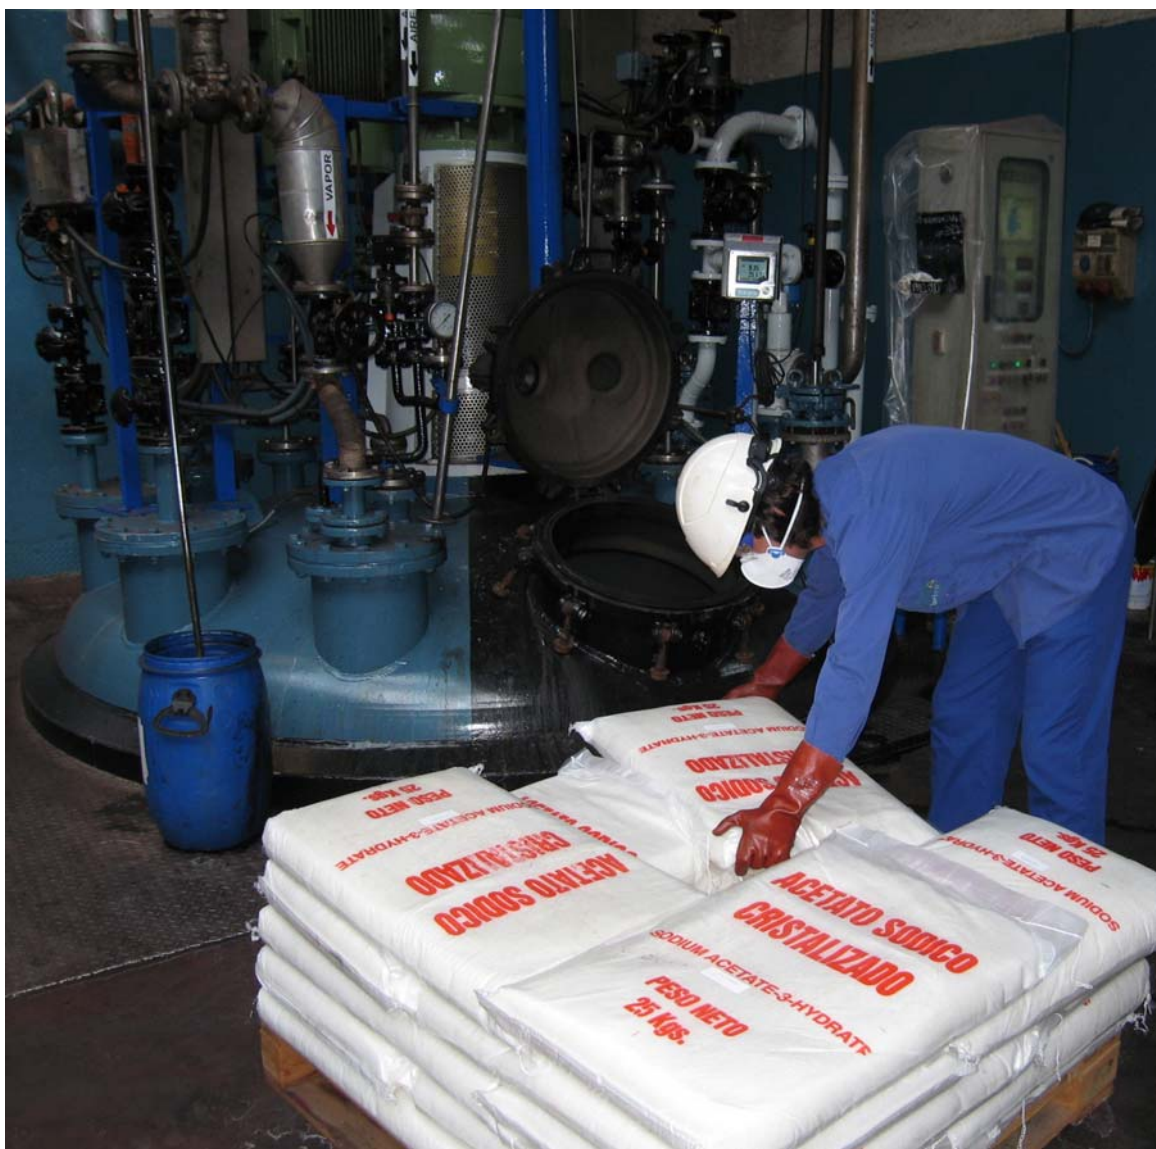
**Figure 1. Loading of sacks before the intervention**

Raw materials for the chemical synthesis come from suppliers in different containers, mostly in sacks (see figure 1). During the analysis different ways of manual handling of these sacks, different types of sack materials (plastic, paper, textile) were compared. The assessment also included the effects of the placing of sacks on the pallets and the height thereof. The following measures were introduced to reduce ergonomic hazards:

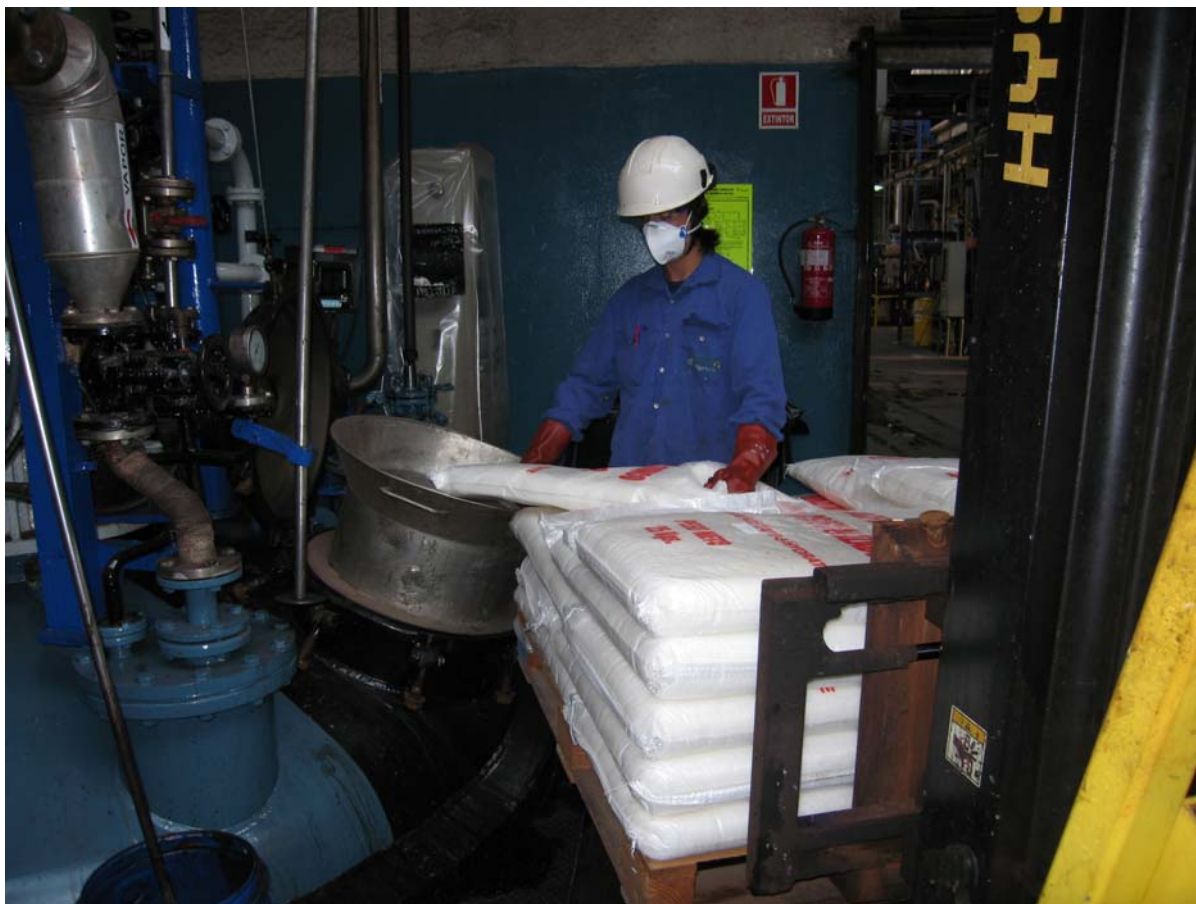
**Figure 2. Loading of sacks after intervention: more ergonomic workflow**

- Engineers developed a funnel for the vessel intake. This has elevated the working height to a more comfortable 70 cm (see figure 2).
- The company issued work instruction showing the right way to carry out manual load handling in general and manual handling of sacks in particular.
- A working group consisting of employees from the purchase, the production and the prevention service departments was set up. The aim of the group was to manage contact with suppliers to minimise the purchase of raw materials in sacks, thus prioritizing the purchases in 'Big-bags'.
- The company organised training for workers on correct manual load handling techniques.
- In the warehouse area they installed a TROMPEX vacuum lifting system for sacks/jerricans to prepare "peaks" of raw materials for production during palletisation.

- Addition of a funnel: EUR 600.
- Purchase of a vacuum lifting system: EUR 9,000.

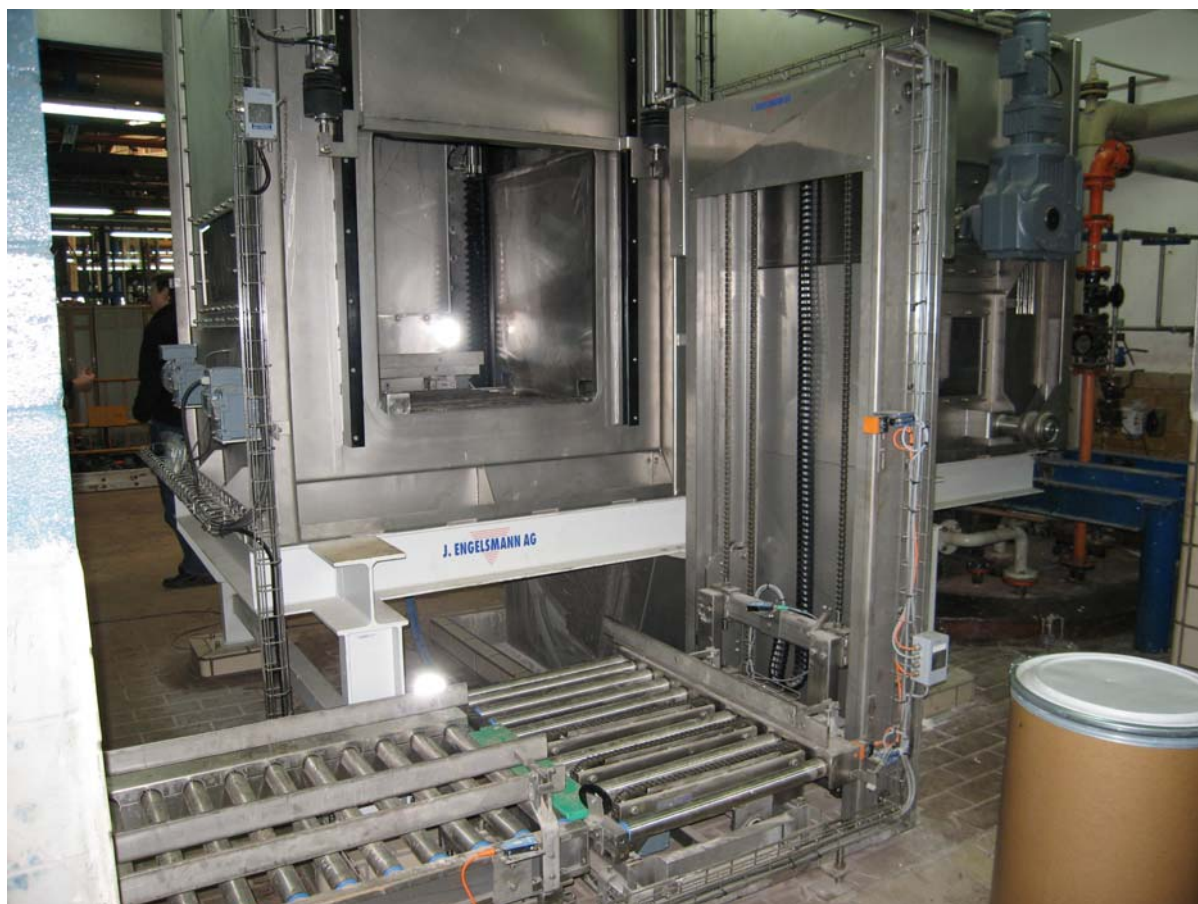
**Figure 3. Automatic intake workstation with lift**

- A funnel was developed for the vessel intake. This directed the drums, thus easing control and also prevents falling of drums or workers into the vessel.
- Drums were replaced by big-bags (that are handled by forklifts) thus eliminating manual handling.
- Staff was trained on the use of the Gator Grip Drum Grab to transfer/place the drums onto the pallets.
- Raw material DCBC is a category 2 carcinogenic substance. The engineering department with an external consultant developed a completely automated and sealed unloading process (see figure 3).

- A GATOR grip drum grab: EUR 600.
- Development of the big-bag system: EUR 3,000.
- Development of the sealed unloading system of drums containing chemical substance DCBC: EUR 700,000.
- Modifying ice/salt cart structure and adding vibrators: EUR 1,500 each.
- Automatic water jet filter cleaning system: EUR 70,000.
- New forklift-pallet-big-bag interface: EUR 600.

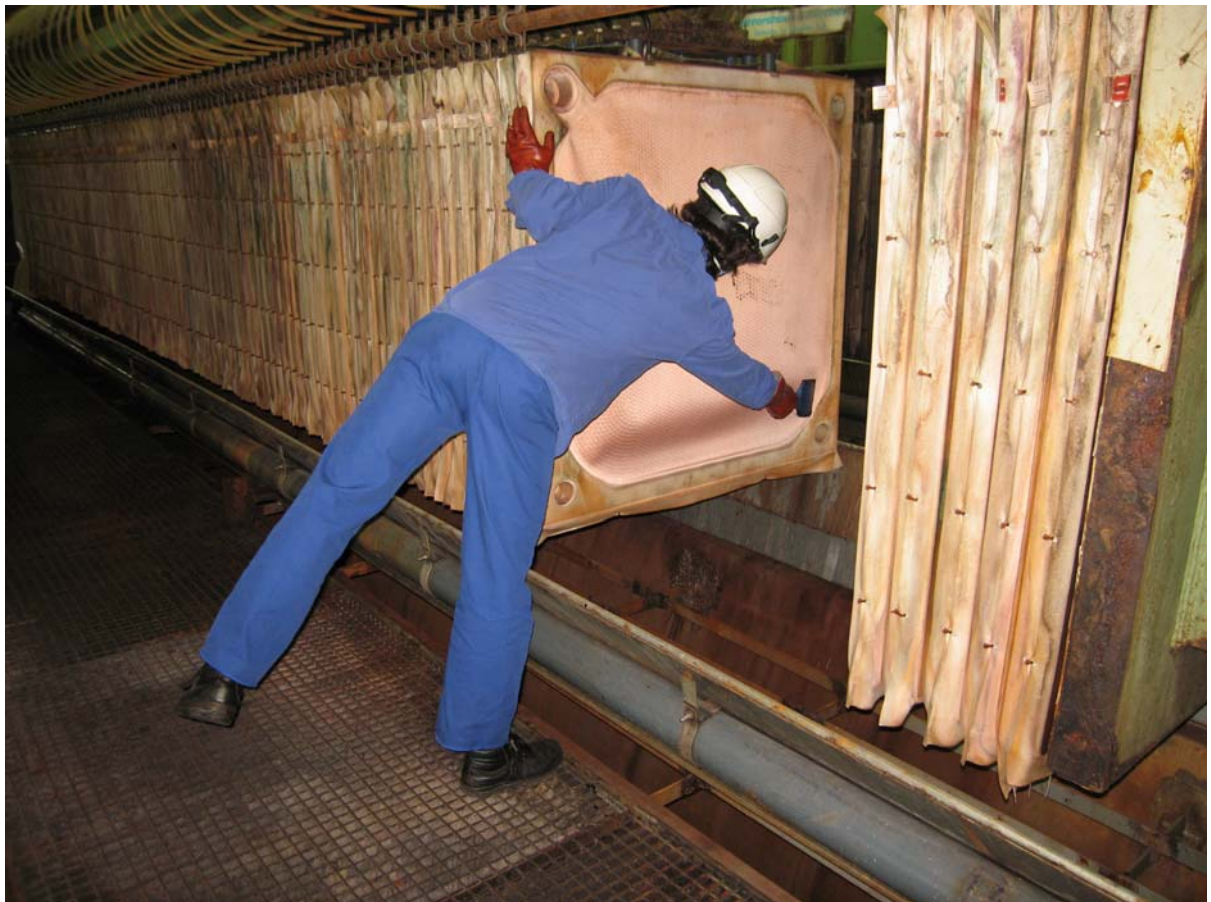
**Figure 4. Manual cleaning of filter with the old spade.**

Filter systems are used to get the dyes and pigments from the solvent. These huge filters used to be unloaded and cleaned manually (see figure 4). The above detailed assessment and analysis of work showed overload, unfavourable ergonomic conditions, risk of loss of balance, and consequent falls.

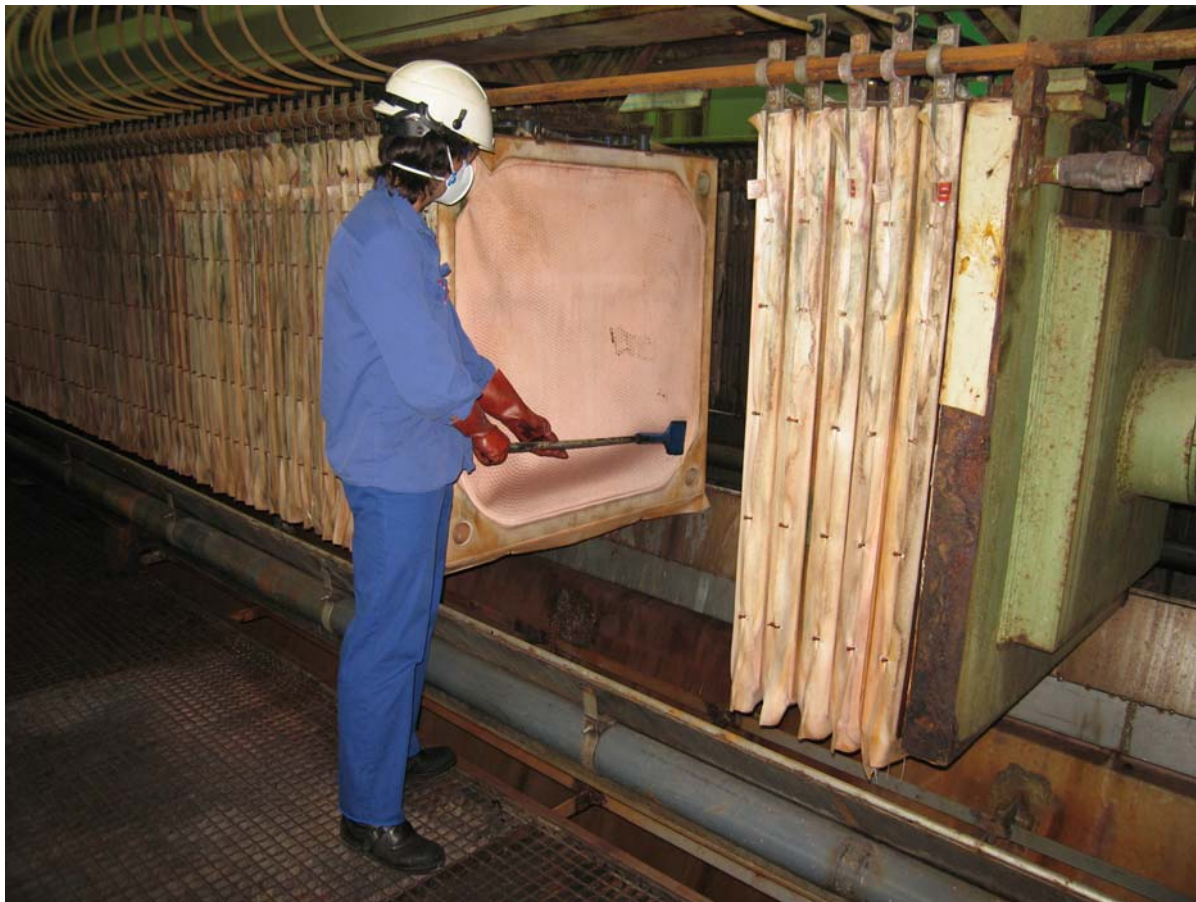
**Figure 5. Modified spade with long handle tackles awkward positions**

- the handle of the spades were elongated to provide access to distant parts of the filter without the need of bending or leaning (see figure 5);
- high pressure water is used for cleaning the channels;
- an automatic cleaner system using water jet was introduced for certain filters.

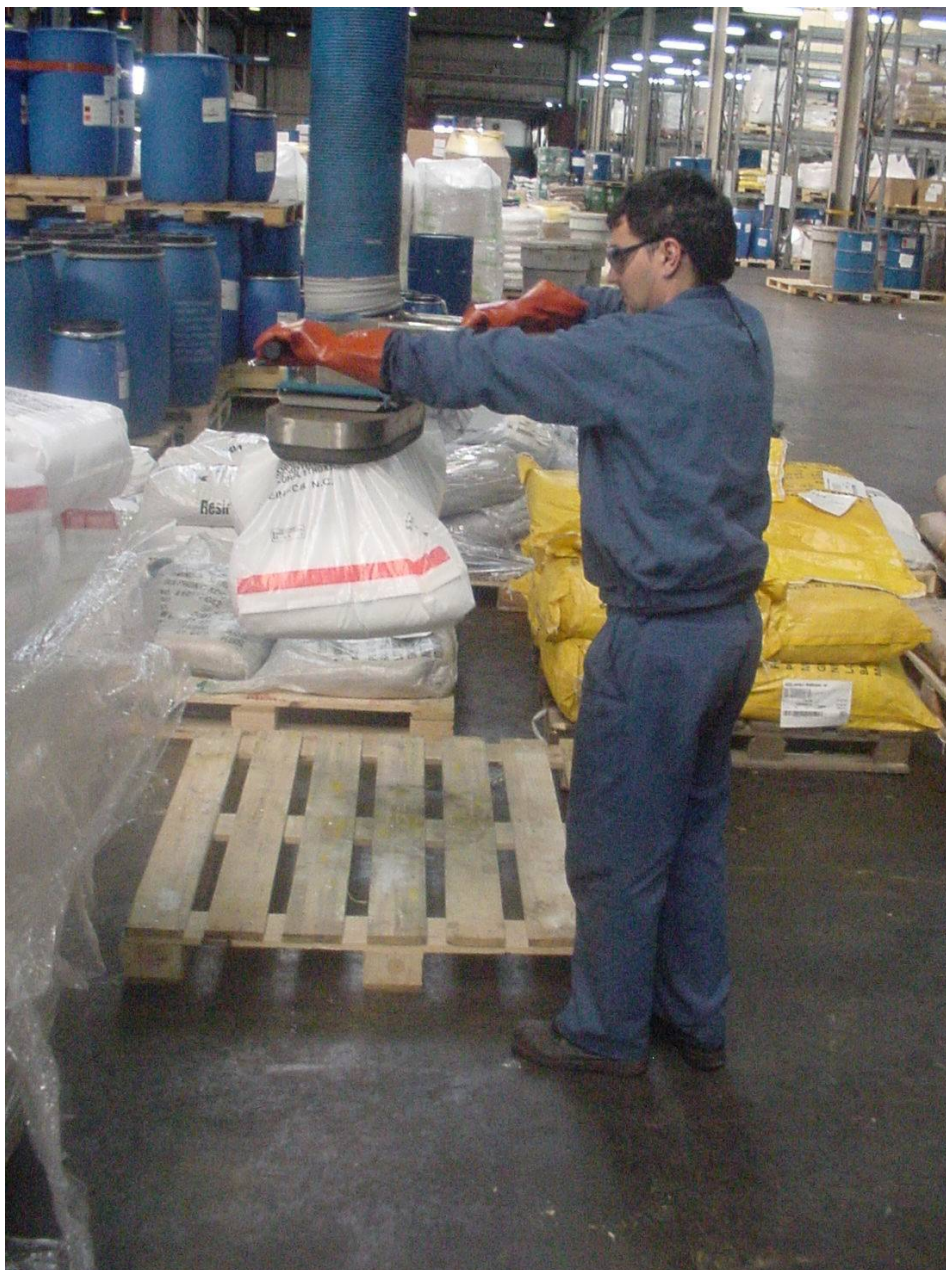
**Figure 6. Vacuum lifting system in operation**

- the company developed a document on proper ways of handling loads, including sacks, drums, big-bags, and also on strengthening exercises for workers;
- bad practices in getting on and off forklift trucks were identified in the analysis of video recordings. These findings were used for the development of the training on proper work techniques;
- the forklifts should be used to adjust work height thus reduce the need for lifting, and for the handling of drums with the GATOR grip drum grab. The company integrated instructions on good practice of filter unloading, getting on and off forklifts into the safety training of workers;
- the company installed a vacuum lifting system into the warehouse area where they pile sacks on the pallets, and one for the production area as well (see figure 6).
