REDUCING THE RISK OF SLIPPING IN A FOOD PROCESSING PLANT

TULIP FOODS Ltd

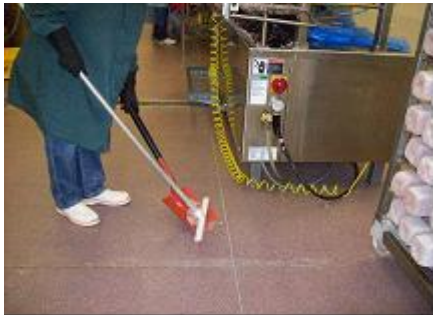
Figure 1. The hygiene team was just scraping up the meat debris, causing the floor to become slippery

1. Most of the slip accidents were happening during the afternoon shift though not exclusively.
2. The cleaning method adopted by the Day Hygiene team actually increased the slip risks. The team found that by just scraping up the meat debris the hygiene operatives were merely spreading a film of meat debris, fat and grease over the floor and that eventually this filled in the surface roughness, causing the floor to become slippery (figure 1).

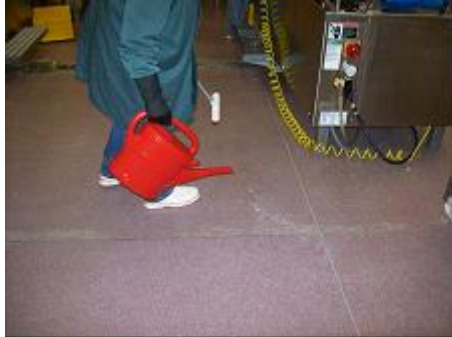
Figure 2. Use of chemicals in small and precise doses

As a result of this investigation, changes were proposed. The method of cleaning the floor was changed to incorporate the use of chemicals to clean up debris, fat and grease. The use of watering cans and small, precise doses of chemicals helped to minimise the risk of food contamination from chemicals. The hygiene operatives used scrapers to remove major debris, as they had done before, then sprinkled chemicals onto the floor, scrubbed and scraped to a drain. This removed the residue of debris, fat and grease and the floor remained non-slip (figures 2, 3, and 4). Known 'high risk' areas

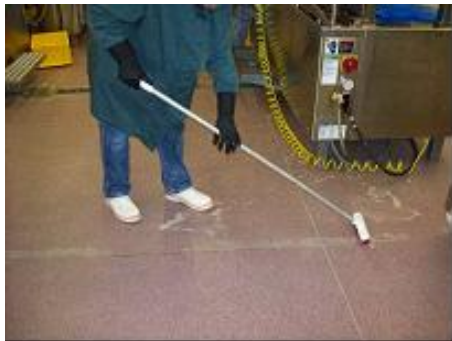
Figure 3. Use of scrapers to remove major debris

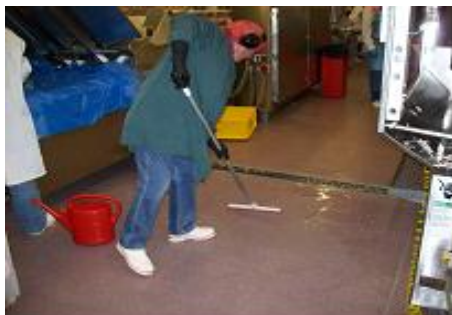
Figure 4. The residue of debris, fat and grease is led to a drain

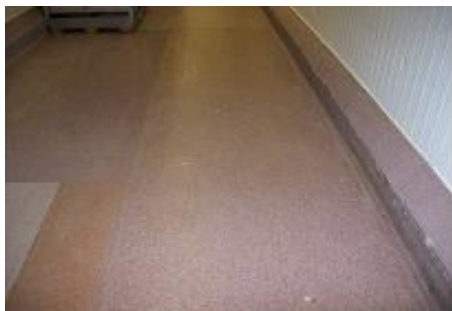
Figure 5. Testing of various floor surfaces with increased roughness

1. Floor surfaces with a surface roughness in excess of 70 μm in high slip risk areas were being tested (figure 5).

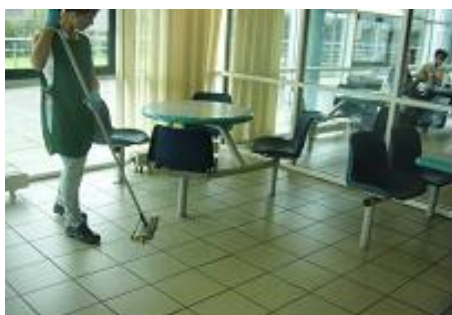
Figure 6. Use of micro fibrous mops to dry the floor after mopping

2. Floor treatments that increase the surface roughness of existing floors and extend their useful life were evaluated.
3. Cleaning procedures were evaluated for welfare areas. Changes to effect a safer cleaning were proposed. These areas generally had ceramic tiled floors and it was therefore imperative that the drying time was minimized. For this purpose, they adopted the use of micro fibrous mops to dry the floor after mopping (figure 6).

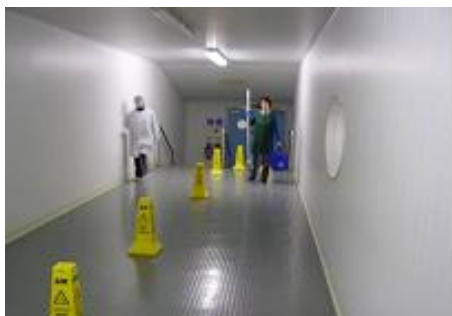
Figure 7. Use of plastic cones to separate pedestrians from the area being cleaned

4. The company was also testing a new procedure for cleaning corridors to effect separation between pedestrians and the area being cleaned (figure 7).
