## CONTROLLING EXPOSURE TO DANGEROUS CHEMICALS WHEN TREATING SURGICAL INSTRUMENTS

Pauls Stradiņš Clinical University Hospital, Riga, Latvia.

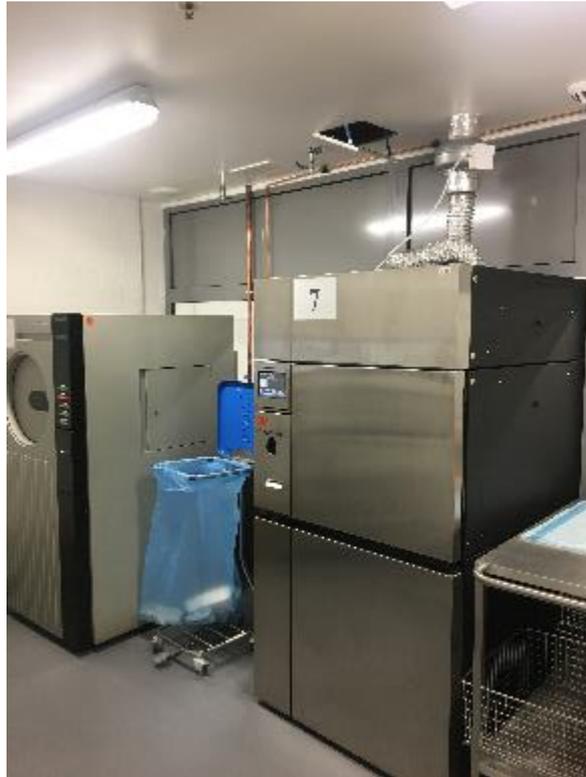
**Picture: sterilisation equipment using ethylene oxide.**

Ethylene oxide gas sterilisers have been used by the hospital for many years to sterilise surgical equipment and supplies that are heat sensitive or cannot tolerate excessive moisture. In other countries, ethylene oxide is also used to produce sterility at room temperature. Ethylene oxide has been recognised as a potential mutagenic, reproductive, carcinogenic, neurological, and fire and explosion hazard to hospital workers (Jho et al., 2007).

In the room where ethylene oxide is used and stored, local exhaust systems and gas analysers are installed. Furthermore, in case the equipment does not stop working in a dangerous situation, there are gas masks and other personal protective equipment located in the department. Ethylene oxide is stored in disposable cartridges in fireproof cabinets in the same room where sterilisation equipment is located.

1. Exposure was prevented through the use of the latest generation of ethylene oxide steriliser. These sterilisers are safer because they continuously control airflow, ethylene oxide presence and concentration.
2. Additionally, gas analysers have been installed for every area where chemical leakage could occur.
