CONTROLLING EXPOSURE TO DANGEROUS CHEMICALS WHEN TREATING SURGICAL INSTRUMENTS

Pauls Stradiņš Clinical University Hospital, Riga, Latvia.

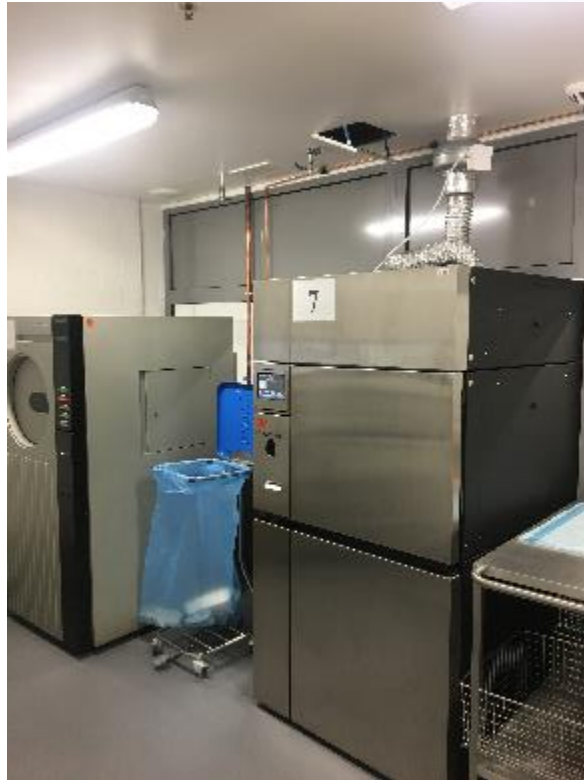
Picture: sterilisation equipment using ethylene oxide.

Ethylene oxide gas sterilisers have been used by the hospital for many years to sterilise surgical equipment and supplies that are heat sensitive or cannot tolerate excessive moisture. In other countries, ethylene oxide is also used to produce sterility at room temperature. Ethylene oxide has been recognised as a potential mutagenic, reproductive, carcinogenic, neurological, and fire and explosion hazard to hospital workers (Jho et al., 2007).

In the room where ethylene oxide is used and stored, local exhaust systems and gas analysers are installed. Furthermore, in case the equipment does not stop working in a dangerous situation, there are gas masks and other personal protective equipment located in the department. Ethylene oxide is stored in disposable cartridges in fireproof cabinets in the same room where sterilisation equipment is located.

1. Exposure was prevented through the use of the latest generation of ethylene oxide steriliser. These sterilisers are safer because they continuously control airflow, ethylene oxide presence and concentration.
2. Additionally, gas analysers have been installed for every area where chemical leakage could occur.
