## EFFECTIVE LEGIONELLA CONTROL AT THE ACADEMIC HOSPITAL SAINT-LUC, BRUSSELS

Cliniques universitaires Saint-Luc, Brussels, Belgium

#### 3.1. Introduction

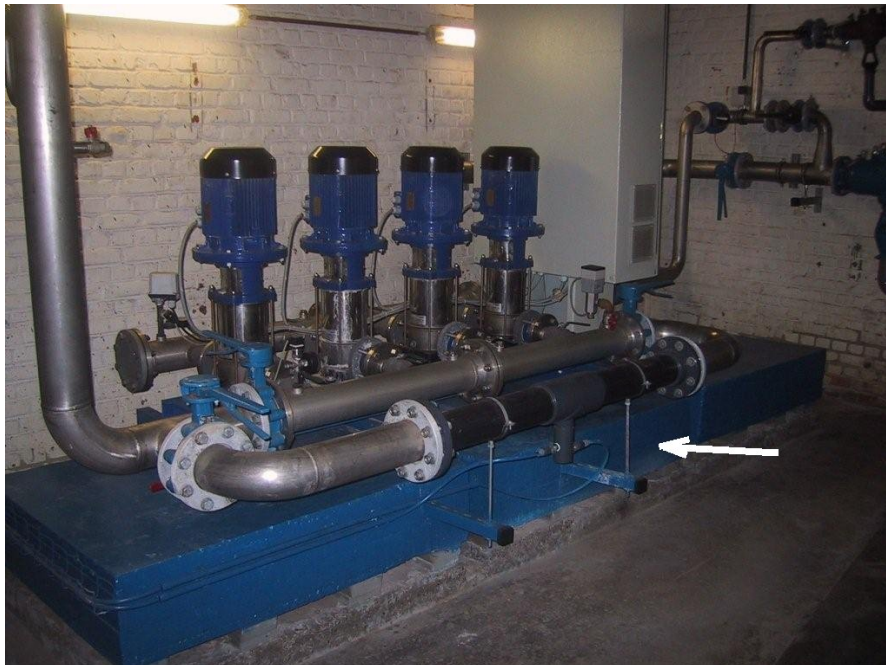
**Picture 2: The pumps of the water supply system, with entry point for chlorine dioxide (see arrow).**

Dr Anne Simon, hygienist at Saint-Luc hospital, decided, in cooperation with the technical and finance departments, to install a new system based on chemical disinfection with chlorine dioxide, bought from Danish water treatment specialists Guldager. Before the chemical disinfection system was installed, the water in the piping system was analysed to determine its compatibility with the chemicals concerned. It was confirmed that the existing piping system is resistant to an average chlorine dioxide concentration of 0.5 ppm, a water temperature of 70 °C, and a pressure of 9 bars during a 24-hour operation [10].

The chemical disinfection at Saint-Luc is done with an automatic chlorine dioxide dosing unit that was easily fitted to the existing piping system [11]. It is based on two chemicals: a saturated solution of oxy chlorine and a solution of blended inorganic acids. By mixing these chemicals, chlorine dioxide is produced according to the requirements (Picture 3). The concentration of chlorine dioxide needed for effective disinfection (0.5 ml/l on average) is much lower than that needed for disinfection with chlorine. Although chlorine dioxide is a potentially dangerous chemical, the concentrations used at the hospital are below current thresholds and the benefits clearly outweigh the risks. After the new control measure was implemented, no legionella could be detected. The risk for maintenance personnel, patients and residents of being infected by *Legionella* bacteria fell to almost zero.

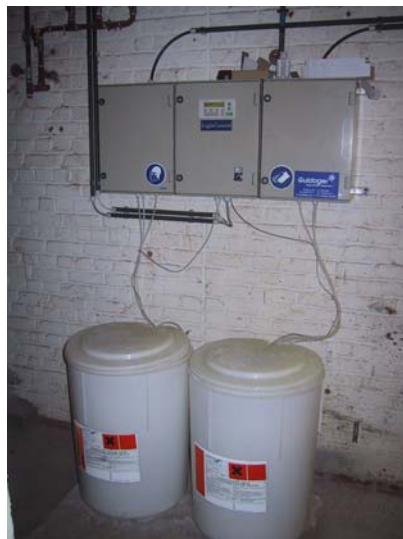
**Picture 3:** Tanks with the two chemicals needed for the disinfection,
