## RISK ASSESSMENT AS AN AID FOR THE PREVENTION OF *LEGIONELLA* CONTAMINATION IN ITALIAN TRAINS

### 2. Description of the case

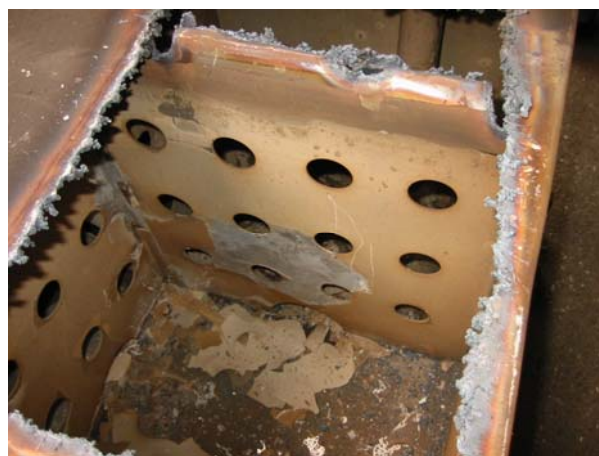
Railway cars (also known as wagons or coaches) have tanks located under the car's roof and non-drinkable water is channelled drop by drop to the toilets and the galley kitchens. Passenger trains' water tanks are made of steel or resin and they may be of various capacities (from 200 to 1,800 litres).

**Picture 1. Visual inspection of a water tank**

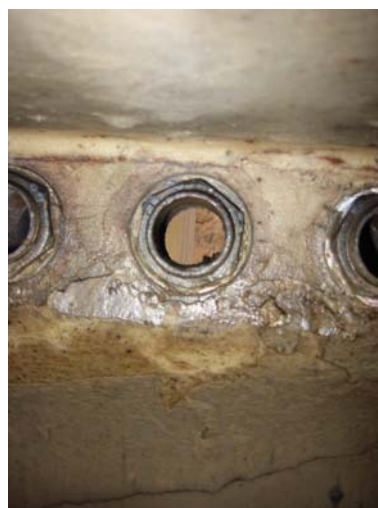
**Picture 2. Sediment and debris on walls and bottom of water tank**

In the case of high bacterial concentrations, disinfection was repeated, the tanks were cleaned and scale and debris were removed from the walls and the bottom of the tank. These measures were taken even in the absence of significant contamination, because bacterial concentration is subject to seasonal variations depending on the temperature in the water tank.
