## **DENTAL LABORATORY – CAPTURING POLLUTANTS AT SOURCE**

Primary health insurance fund (CPAM) laboratory in Lyon — Regional health insurance fund (CRAM) Rhone-Alpes.

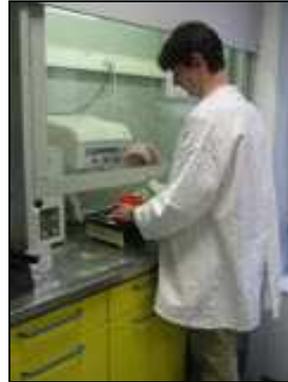
**Figure 1. Preparation of coatings and de-moulding of cylinders now takes place under a suction hood to reduce dust emission**

boxes). Preparation of the coatings, which involves handling highly silicogenic products for short periods, is performed under exhaust ventilation, using a swivelling collector for ceramic work and by working under a fume cupboard (suction hood with a raisable screen) when handling dental prostheses.
